**5,000 Volt AC Leakage Test Report  
2-1/16" API 10K**

**For Vniigaz/Astrakhan Gazprom GPU**

**June 13, 2003**

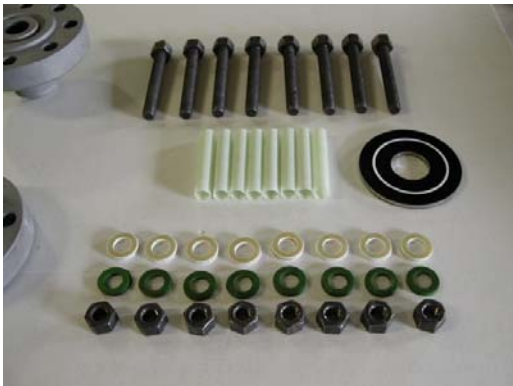
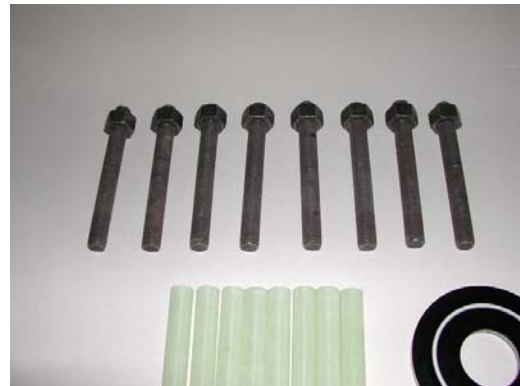
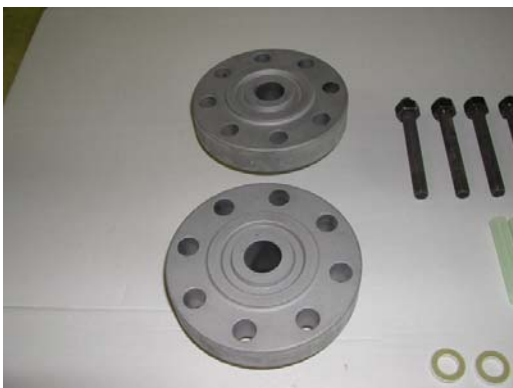
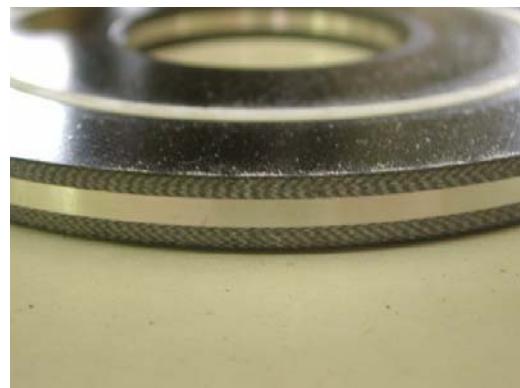
On June 9, 2003, Pikotek conducted a 5,000 volt AC leakage test on an API 2-1/16" – 10K flange assembly using the following components/materials:

1 each VCS insulating gasket with 316 ss core and 0.093 per side of G-10 insulating material (0.308" total gasket thickness). One spring-energized Teflon seal per side located outside of the ring joint groove.

The purpose of this test was to examine the functionality of the new insulating gasket design for Gazprom following unsuccessful tests conducted in the field.

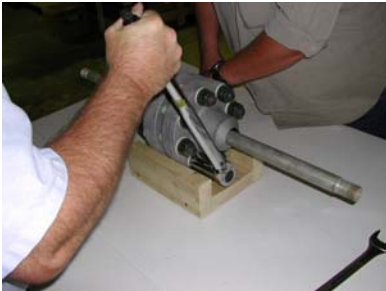
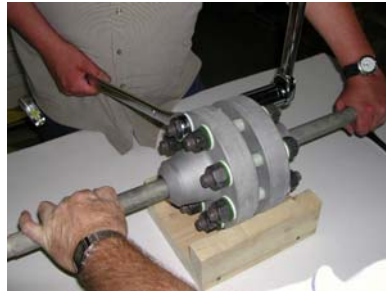
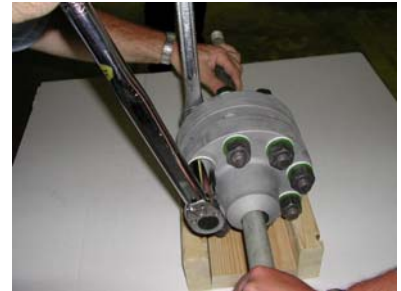
Following assembly and make-up to the prescribed bolt torque, the flanges were then checked for electrical continuity using a Fluke multi-meter. The result of this test showed that no continuity was present and that the flanges were insulated to a reading of .OL (infinite resistivity).

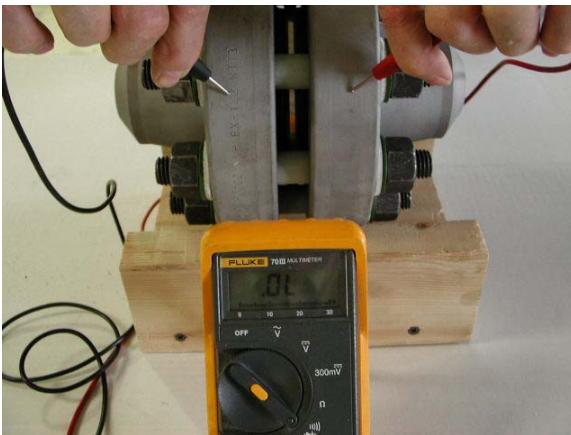
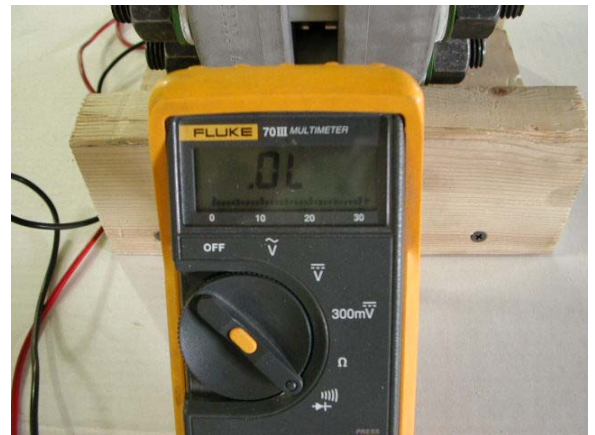
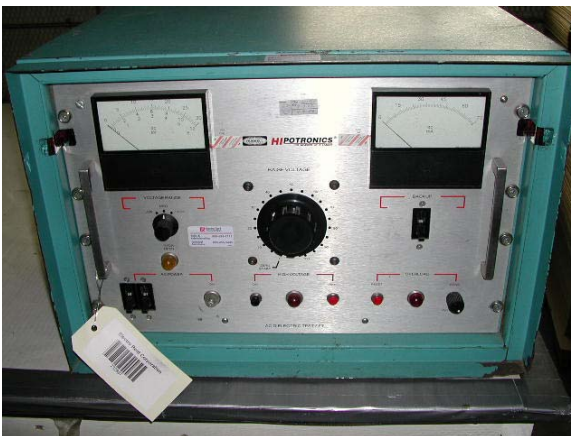
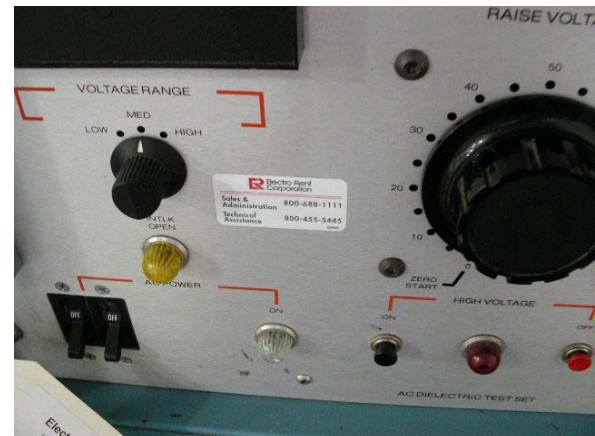
Once the flanges were assembled and tested for electrical isolation, the AC voltage regulator was then hooked up to the ends of the flanges. The machine used to carry out the AC leakage test was a Hipotronics Model HIP-730-2 which is described as a 30kV AC UL Hipot capable of generating up to 30 kVA of voltage (see calibration certificate attached).

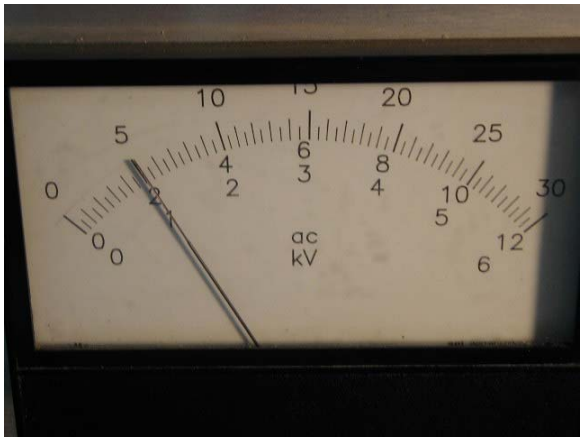
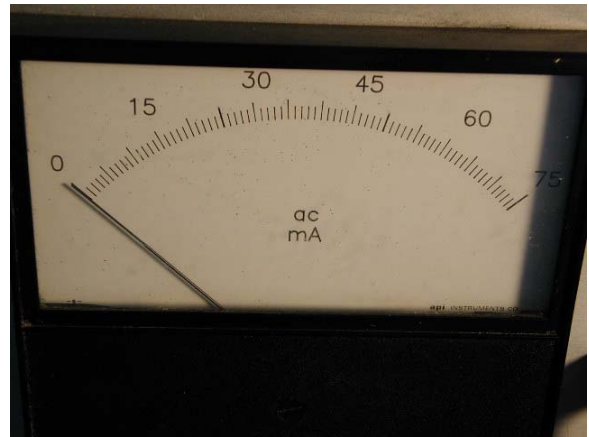
The machine was powered up and the voltage was increased from 0 to 1,000 volts AC (60 mhz) and held for a period of 1 minute with no amperage (mA) current leakage.

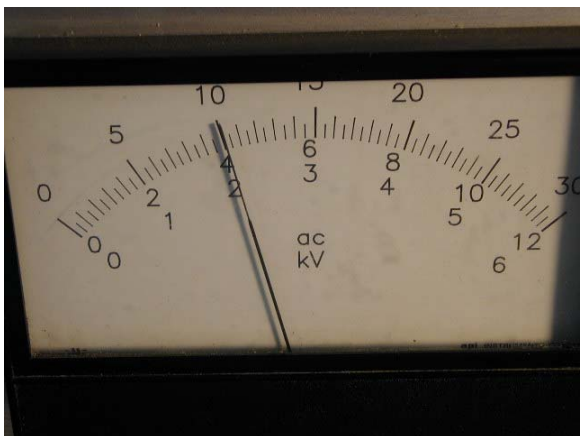
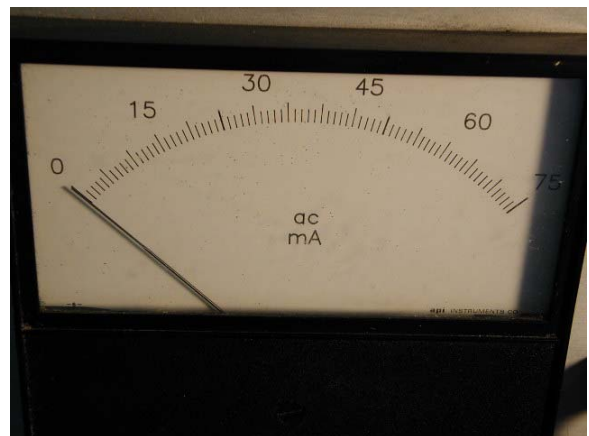
Following the 1 minute hold at 1,000 VAC, the voltage was then turned up to 2,000 volts AC and held for a period or 1 minute with again no current leakage.

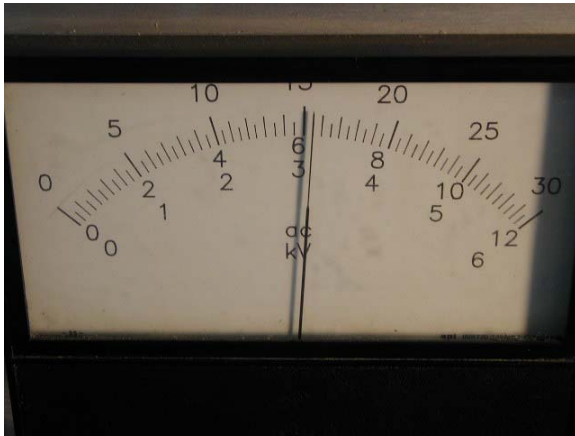
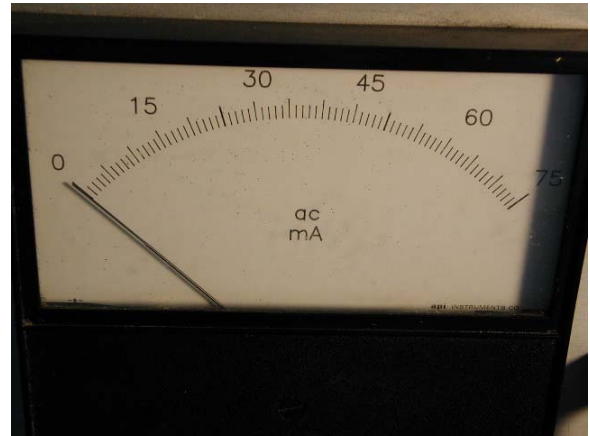
Following the 1 minute hold at 2,000 VAC, the voltage was then turned up to 3,000 volts AC and held for a period of 1 minute with again no current leakage.

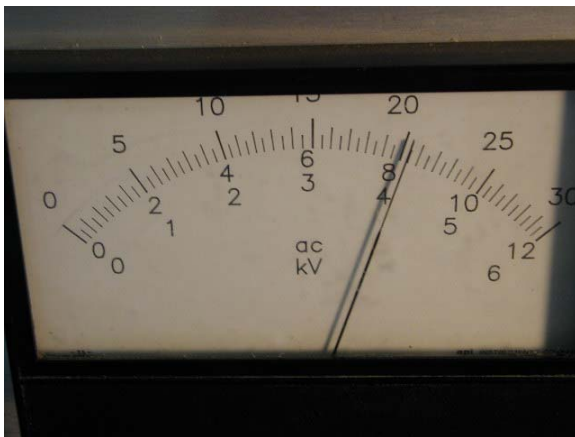
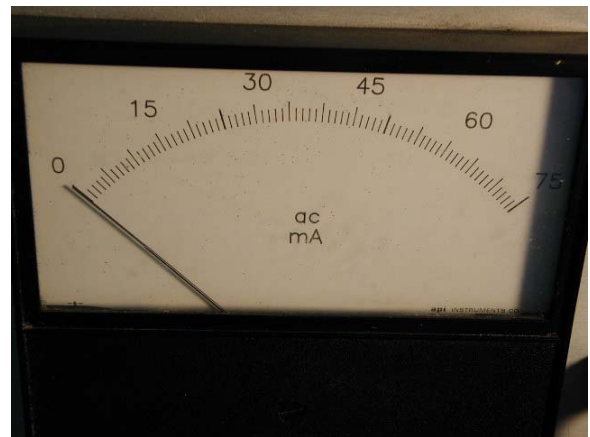
Following the 1 minute hold at 3,000 VAC, the voltage was then turned up to 4,000 volts AC and held for a period of 1 minute with again no current leakage.

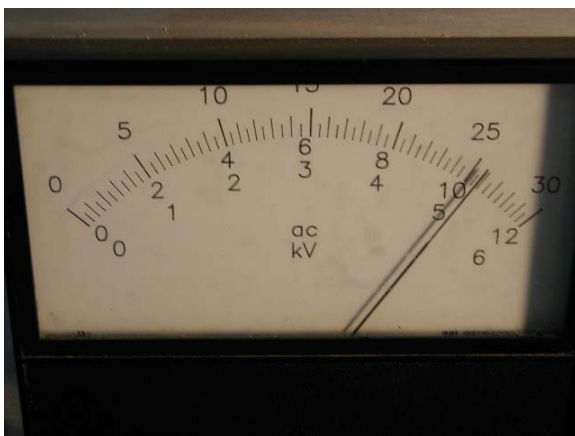
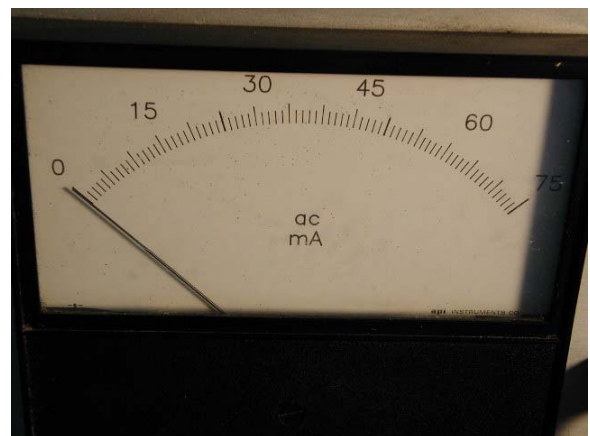
Following the 1 minute hold at 4,000 VAC, the voltage was then turned up to 5,000 volts AC and held for a period of 1 minute with again no current leakage.
