**5,000 Volt AC Leakage Test Report
2-1/16" API 10K**

For Vniigaz/Astrakhan Gazprom GPU

June 13, 2003

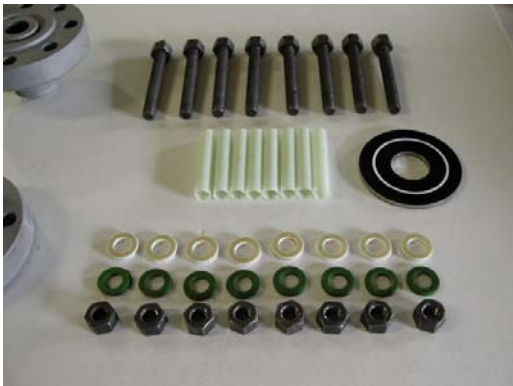
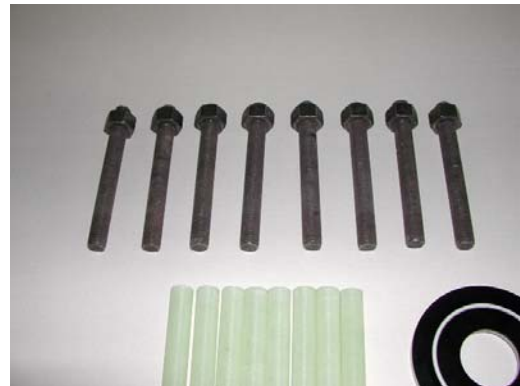
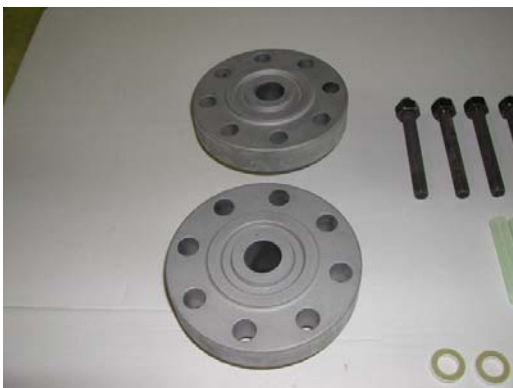
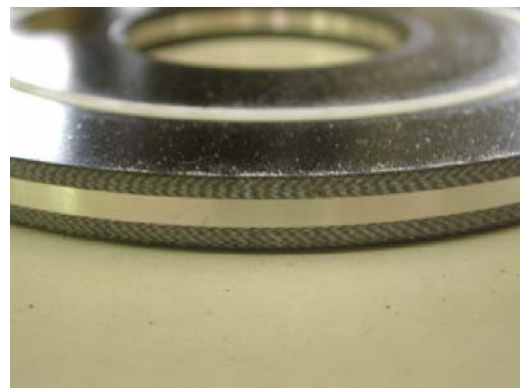
1 each VCS insulating gasket with 316 ss core and 0.093 per side of G-10 insulating material (0.308" total gasket thickness). One spring-energized Teflon seal per side located outside of the ring joint groove.

The purpose of this test was to examine the functionality of the new insulating gasket design for Gazprom following unsuccessful tests conducted in the field.

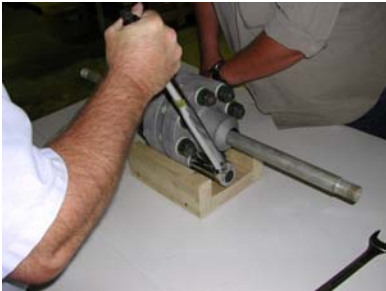
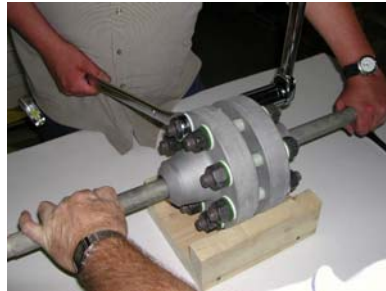
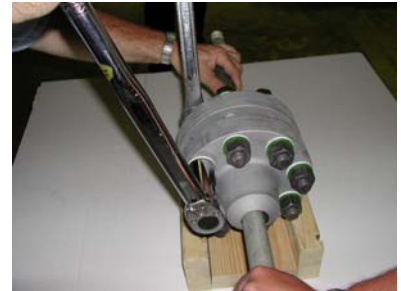
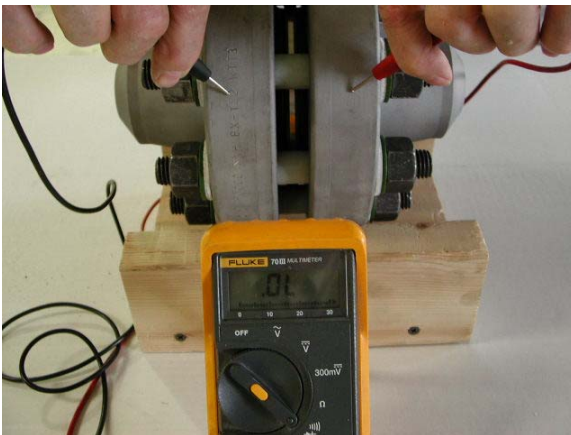
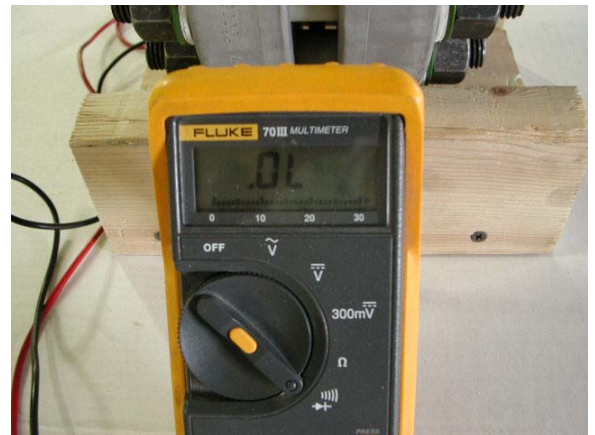
Following assembly and make-up to the prescribed bolt torque, the flanges were then checked for electrical continuity using a Fluke multi-meter. The result of this test showed that no continuity was present and that the flanges were insulated to a reading of .OL (infinite resistivity).

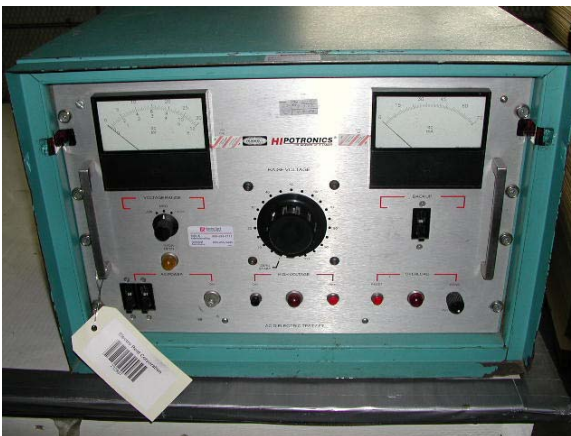
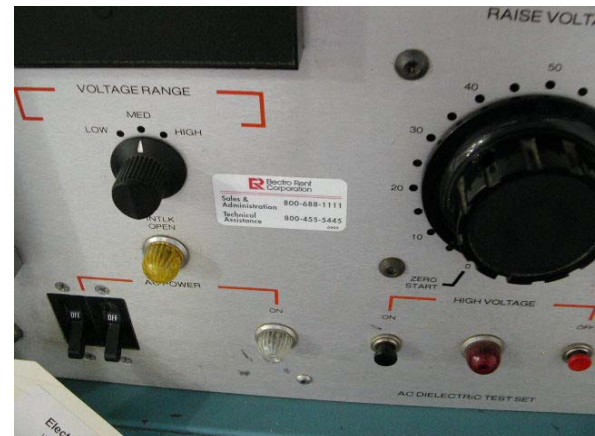
Once the flanges were assembled and tested for electrical isolation, the AC voltage regulator was then hooked up to the ends of the flanges. The machine used to carry out the AC leakage test was a Hipotronics Model HIP-730-2 which is described as a 30kV AC UL Hipot capable of generating up to 30 kVA of voltage (see calibration certificate attached).

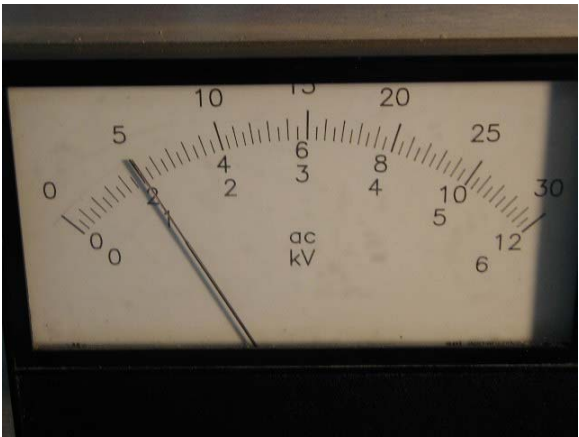
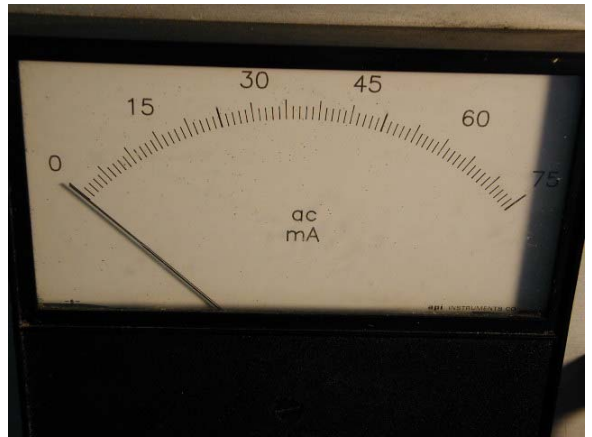
The machine was powered up and the voltage was increased from 0 to 1,000 volts AC (60 mhz) and held for a period of 1 minute with no amperage (mA) current leakage.

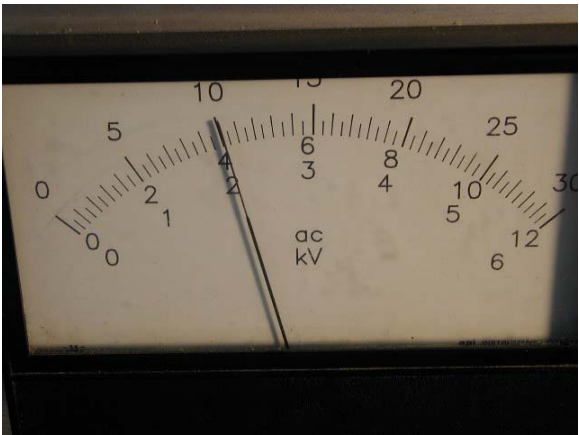
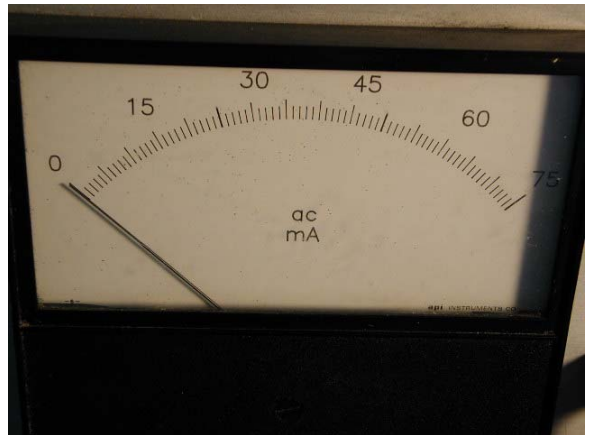
Following the 1 minute hold at 1,000 VAC, the voltage was then turned up to 2,000 volts AC and held for a period or 1 minute with again no current leakage.

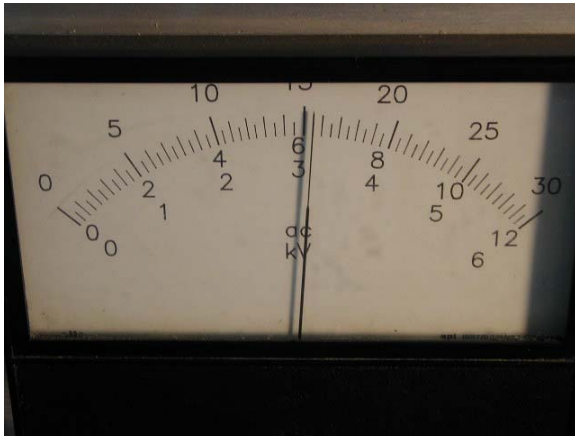
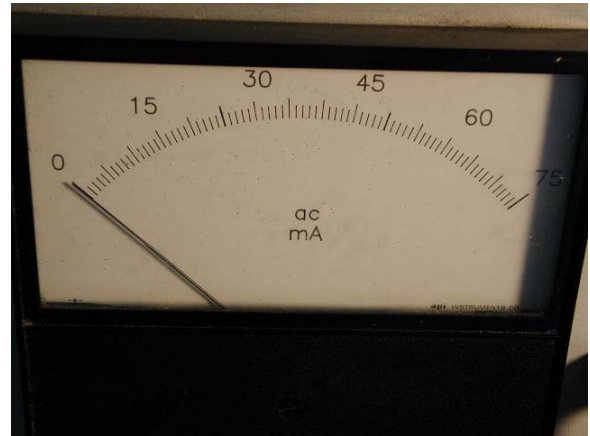
Following the 1 minute hold at 2,000 VAC, the voltage was then turned up to 3,000 volts AC and held for a period of 1 minute with again no current leakage.

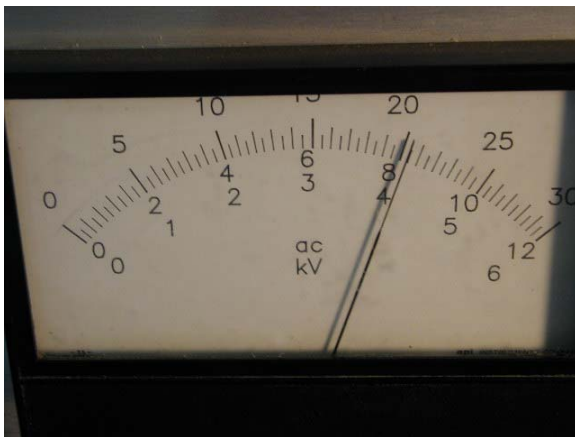
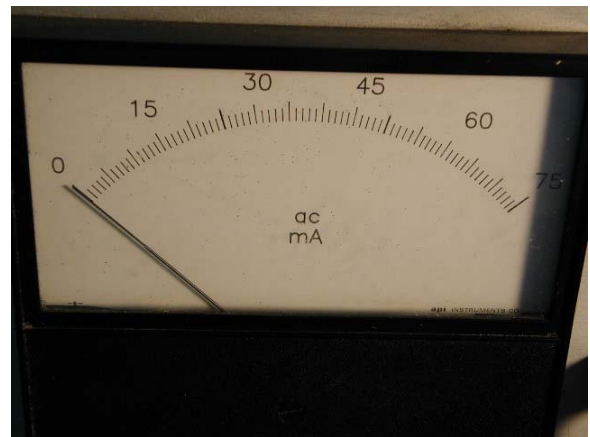
Following the 1 minute hold at 3,000 VAC, the voltage was then turned up to 4,000 volts AC and held for a period of 1 minute with again no current leakage.

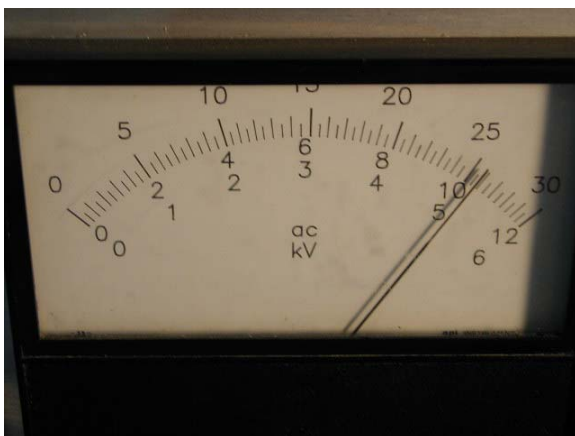
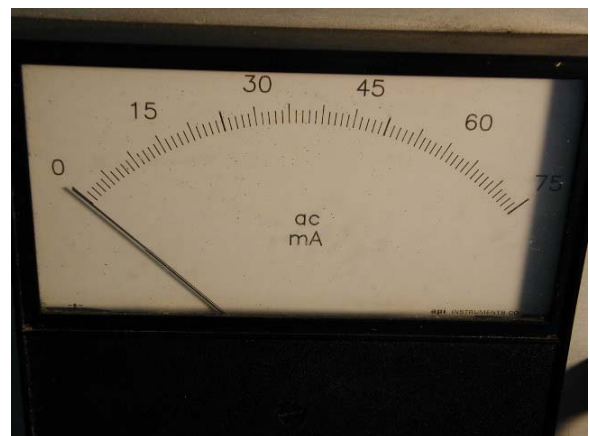
Following the 1 minute hold at 4,000 VAC, the voltage was then turned up to 5,000 volts AC and held for a period of 1 minute with again no current leakage.
